REPORT DOCUMENTATION PAGE		READ INSTRUCTIONS BEFORE COMPLETING FORM
1. REPORT NUMBER	2. GOVT. ACCESSION NO.	3. RECIPIENT'S CATALOG NUMBER
AD-A092038		
4. TITLE (and Subtitle) Phase I Inspection Report Mt. Beacon Reservoir Hudson River Basin, Dutchess County, New York Inventory No. 026		5. TYPE OF REPORT & PERIOD COVERED Phase I Inspection Report National Dam Safety Program

19. KEY WORDS (Continue on reverse side if necessary and identify by block number) Dam Safety National Dam Safety Program Visual Inspection Hydrology, Structural Stability Mt. Beacon Reservoir Dam Dutchess County Dry Brook

PHASE I INSPECTION REPORT
NATIONAL DAM SAFETY PROJECT
MOUNT BEACON RESERVOIR DAM
I.D. NO. N.Y. 26
D.E.C. NO. 537
HUDSON RIVER BASIN
DUTCHESS COUNTY, NEW YORK

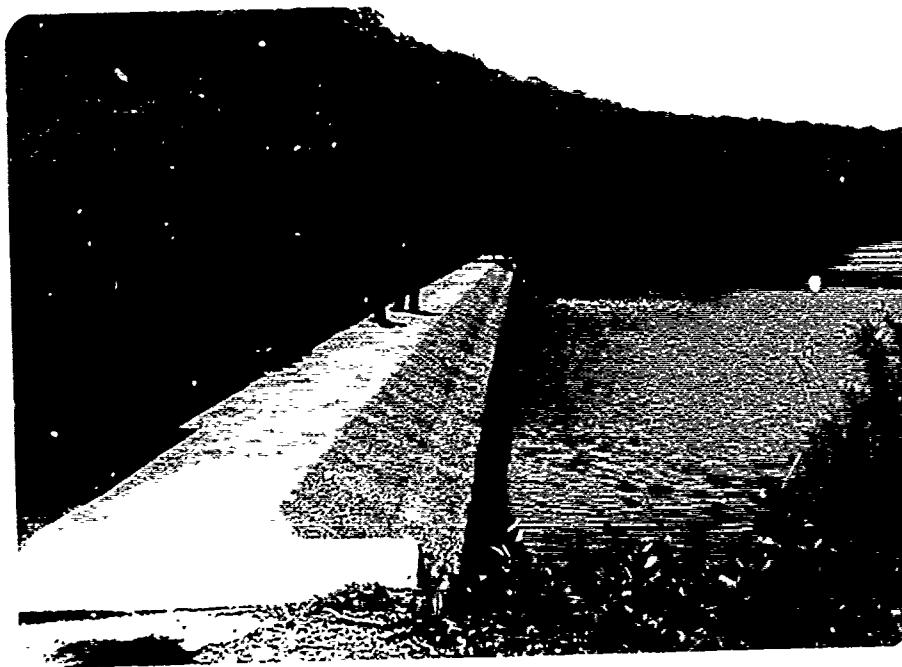
2. UPSTREAM VIEW OF DAM

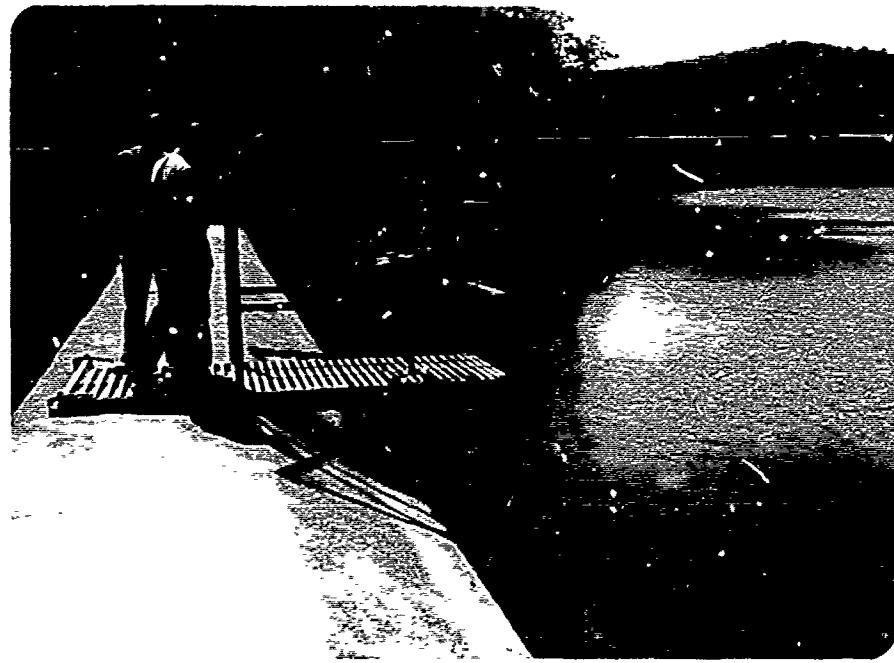
4. VIEW OF UPSTREAM REGULATING CONTROL FOR RESERVOIR DRAIN.

Present Condition (Describe): There are two gate valves located
at upstream and downstream of the dam. Both gates valves
were operated and generally in good condition. The

Operating stem of the downstream gate is rusted; however
does not effect the operation.

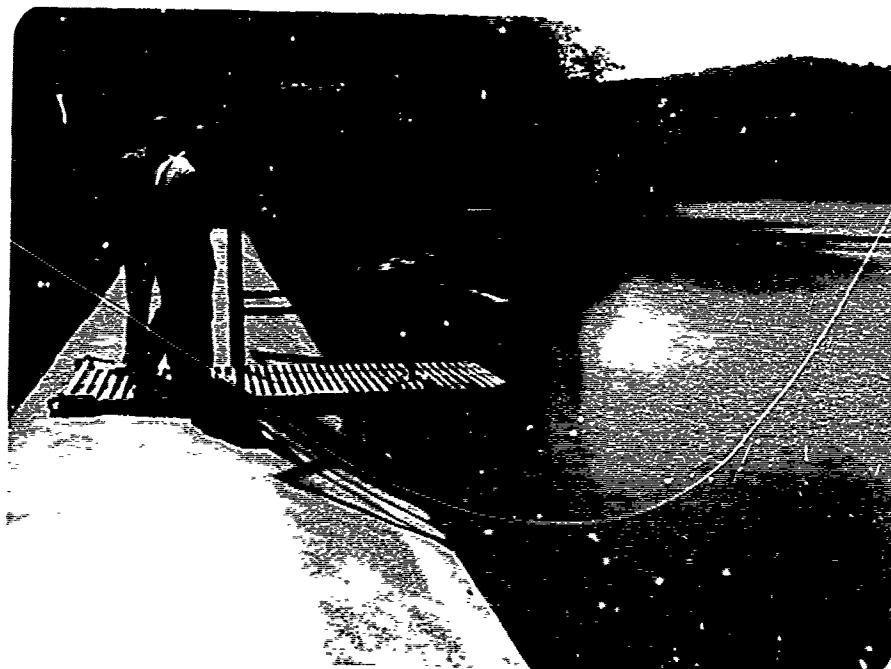
5. VIEW OF AREA DOWNSTREAM OF DAM. NOTE: THE GATE HOUSE IN WHICH DOWNSTREAM REGULATING CONTROL IS LOCATED.

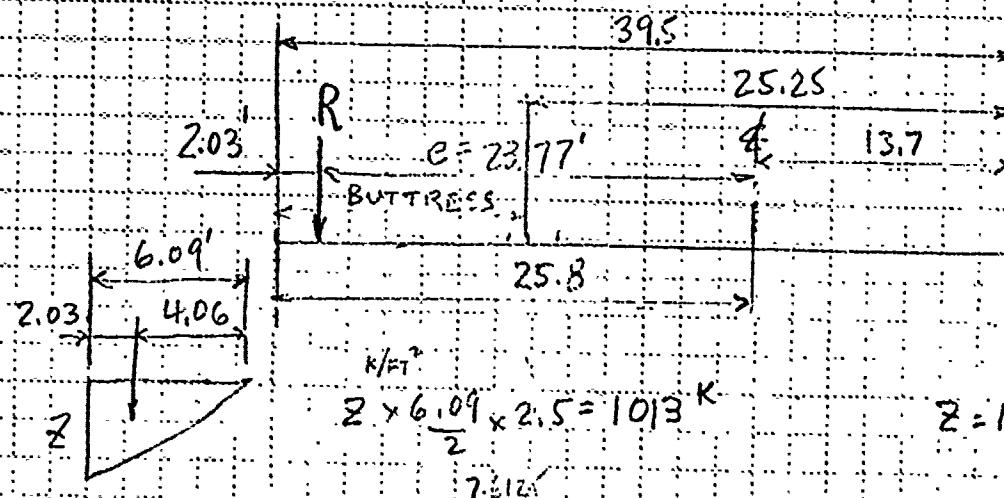
I RESULTANT OUTSIDE MIDDLE HALF

AND ALMOST OUTSIDE OF STRUCTURE

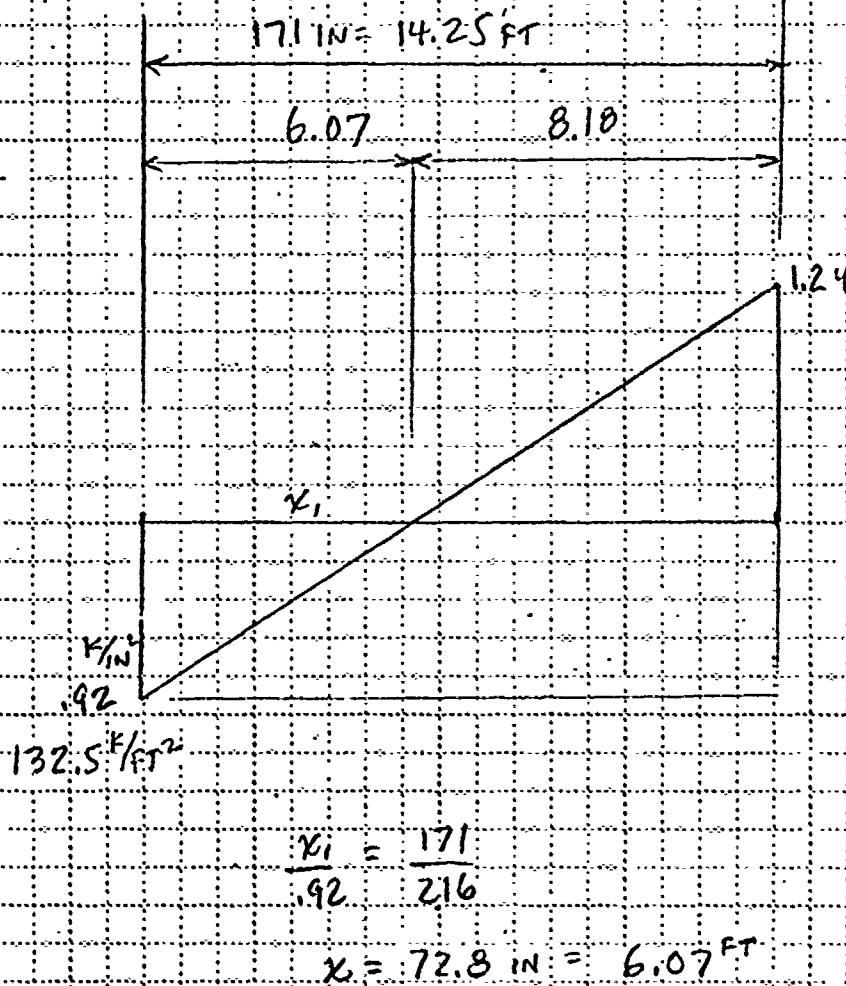
DAM CITY OF BEACON, N.Y.
 NON-OVERFLOW SECTION CASE I
 STRESS psi

These results indicate that the section is ^{for case 1} inadequate especially since a second

The base area should be 100% in compression for the normal loading condition.

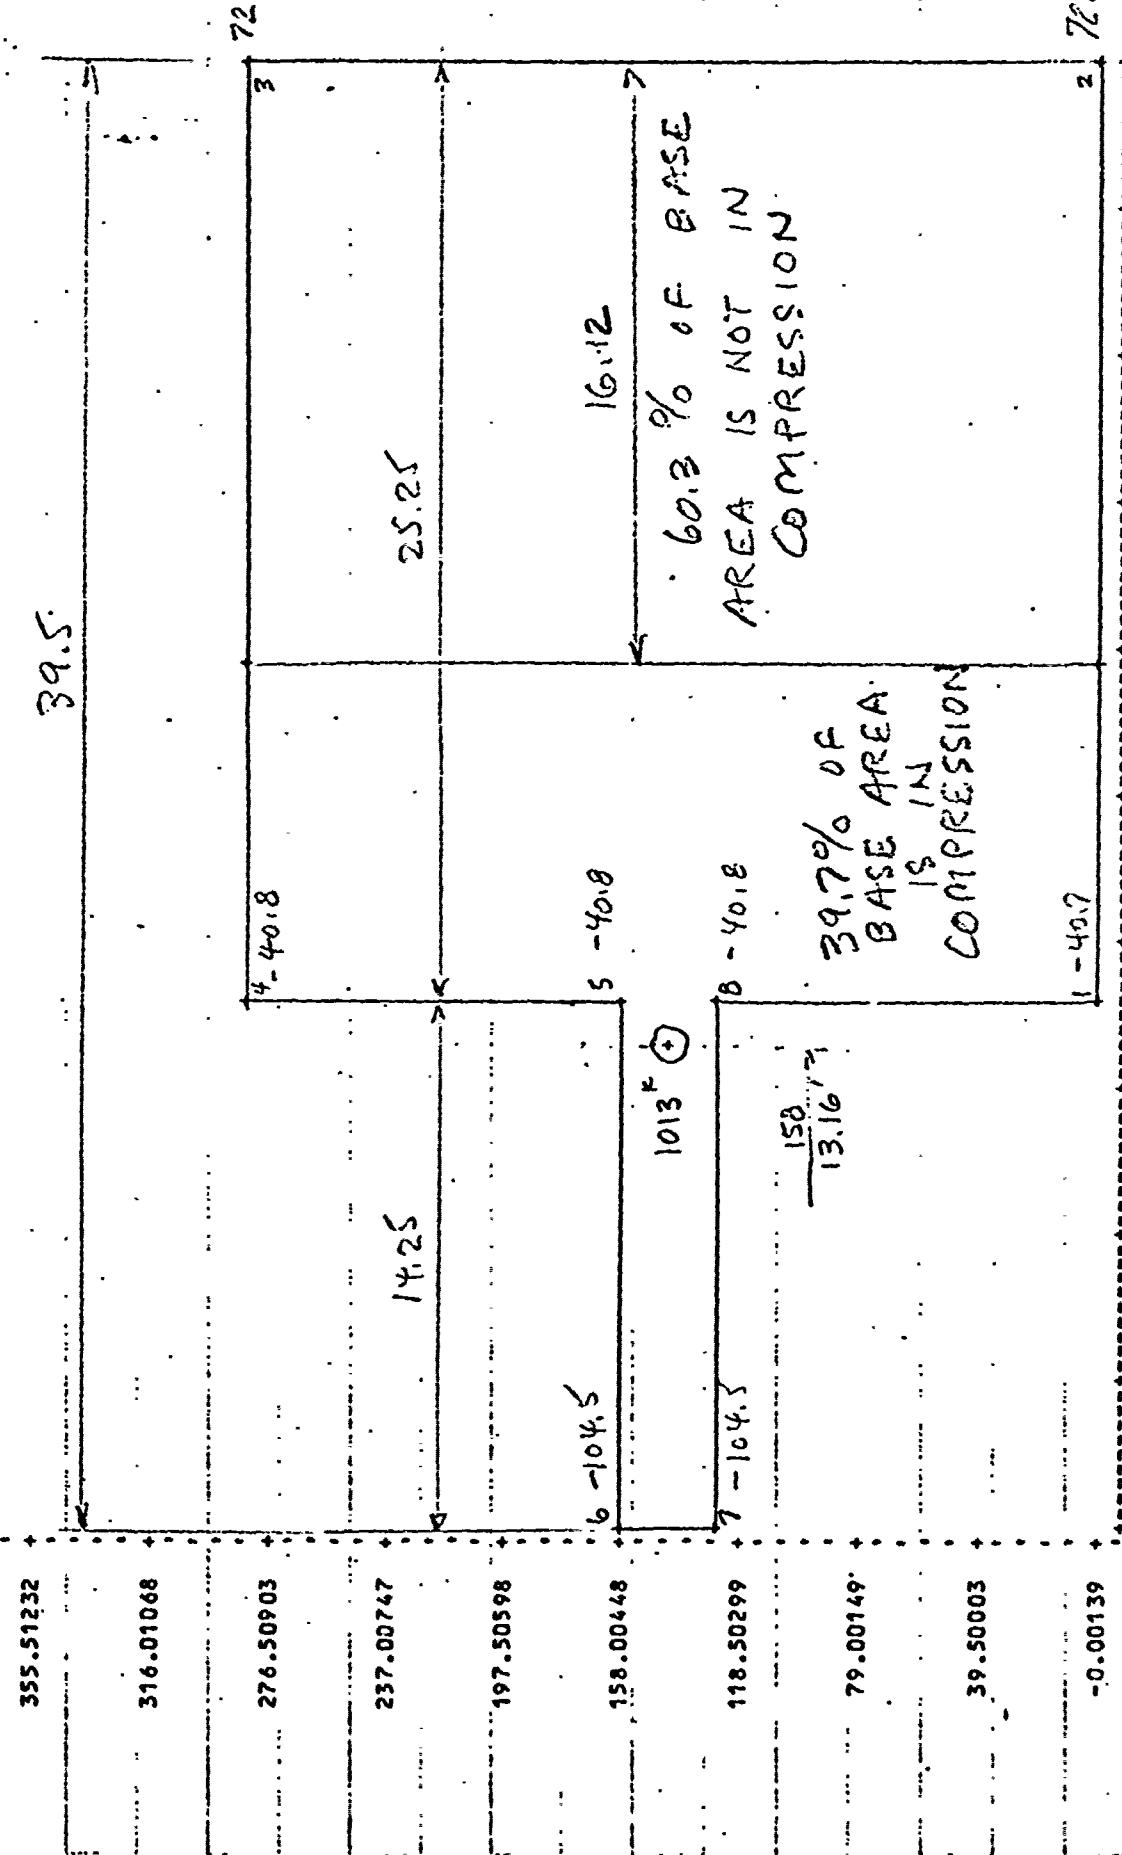
NON-OVERF. SECTION CASE 2

FIRST TRIAL : With base area assumed 100% in compression, calculations indicate that only 39.7% of base area is in compression and sliding F.S. = 1.06. These results indicate that the section is inadequate for CASE 2. See comments to case 1.

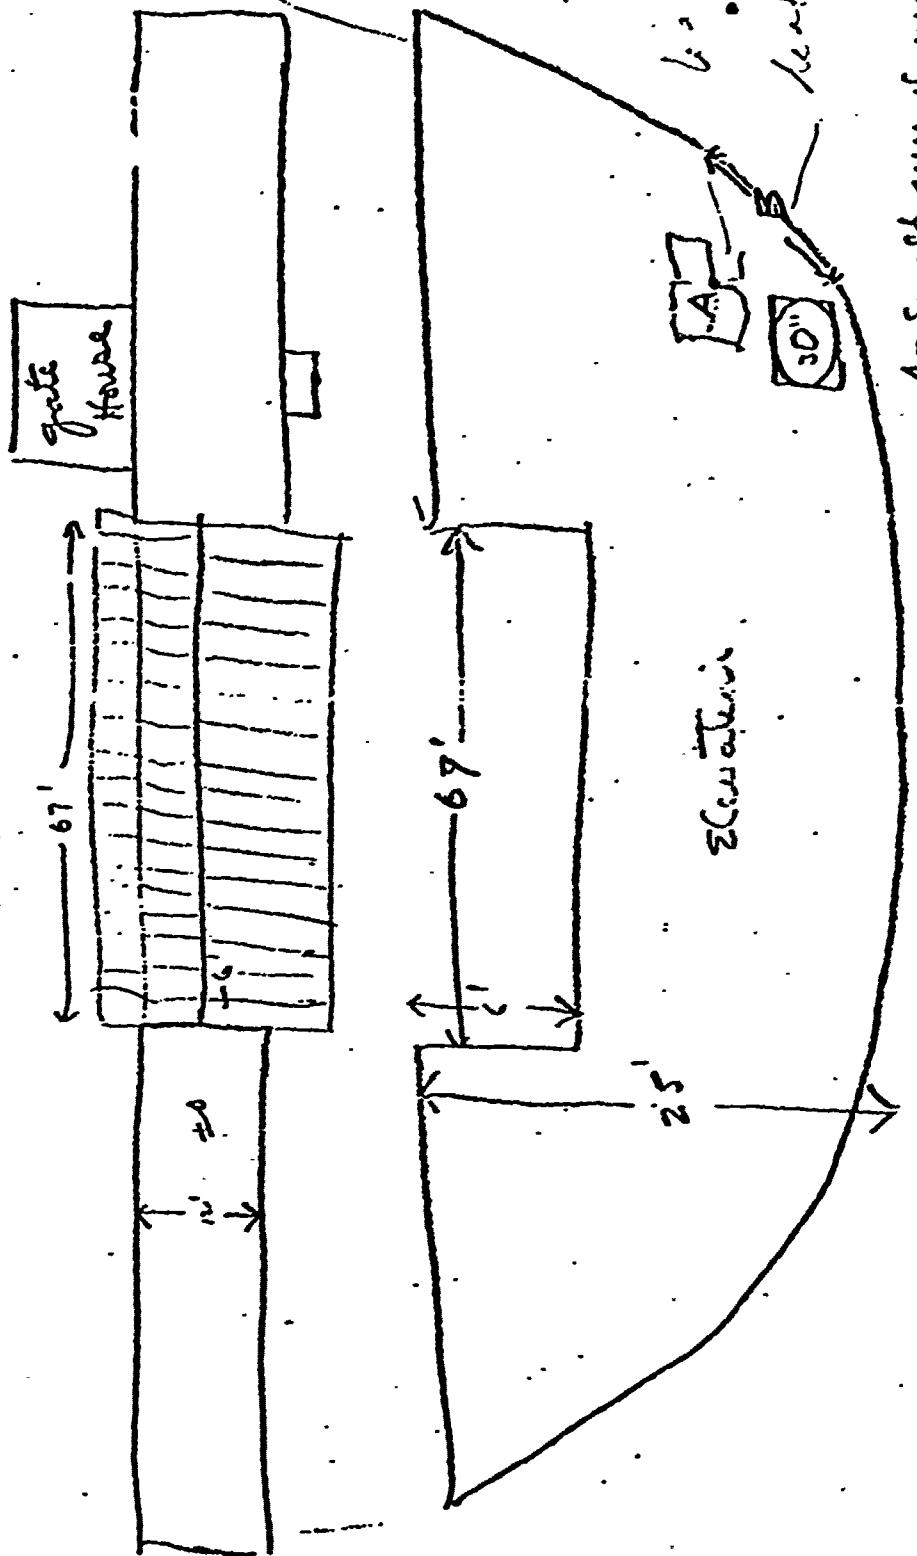
Surface of concrete is spald
 Some leakage near Spillway about 18"
 below crest

A - Small area of water

B - along this active line is
a triturating
